ENVIRONMENTAL AUDIT
COASTAL DEGRADATION - GUNN HILL

LESSONS-LEARNED REPORT

**COASTAL DEGRADATION - GUNN
HILL**

This is a Report of an Environmental
Audit conducted by the Office of the
Auditor General

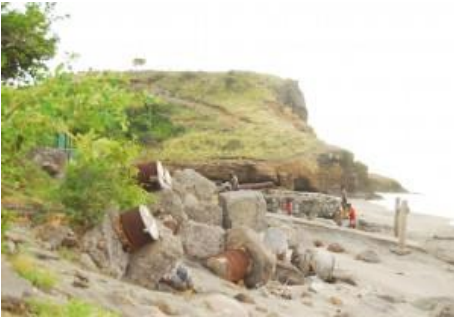
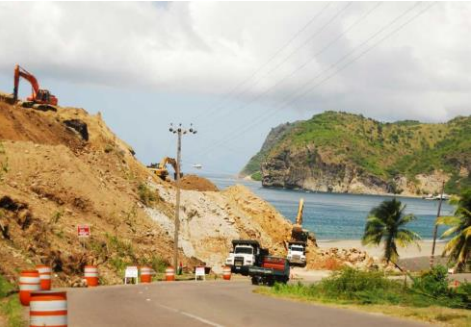
Description and Key Lessons-Learned	
<p>Background & Brief Description of Gunn Hill</p>	<p>The Government of Montserrat engaged Halcrow Group Ltd in 2013 to design a proposed port and produce an Environmental Impact Assessment (EIA) for the development of a Port Facility at Carr’s Bay. A key decision stemming from the proposed development was the need to remove Gunn Hill to make way for the new port.</p> <p>Gunn Hill was in the lower Collins Ghaut River Valley near Carr’s Bay on the north-western flanks of the Centre Hills between the Silver Hills and Centre Hills volcanic centres. The coastline was classified as rocky coastal cliff. These cliffs are a common feature of the Montserrat coastline, comprising 32km or 71% of the coastline.</p> <p>The Planning and Development Authority (PDA) requested that an environmental screening note be provided in support of the Government of Montserrat’s (GOM’s) decision and application to remove Gunn Hill which was completed in April 2013. It was reported that following the application of this screening exercise, in conjunction with a site assessment by the Department of Environment and consultations with representatives of the Public Works Department, it was confirmed that the project to remove Gunn Hill was unlikely to have significant effects on the environment.ⁱ</p> <p>The removal of Gunn Hill was procured and contracted within the Ministry of Finance and Economic Management (MOFEM). The MOFEM contracted Selsi Limited for the removal of Gunn Hill. The area was reduced from an altitude of between 31.5 – 45.7m at its highest point to 4.0m as shown below.</p> <div style="display: flex; justify-content: space-around;">

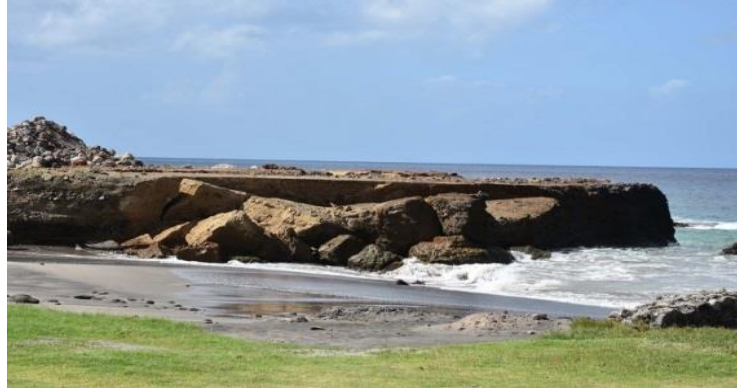
(Photo Credit: The Montserrat Reporter, 2013)

The southern part of the hill was sloped up at a 1 in 2 slope to blend in with the existing hill adjacent to the prison facility. During the excavation/removal an estimated 86,000m³ of primarily coarse grain material and boulders were removed. The bulk of the material was transported to Little Bay and was used as general fill at various sites.

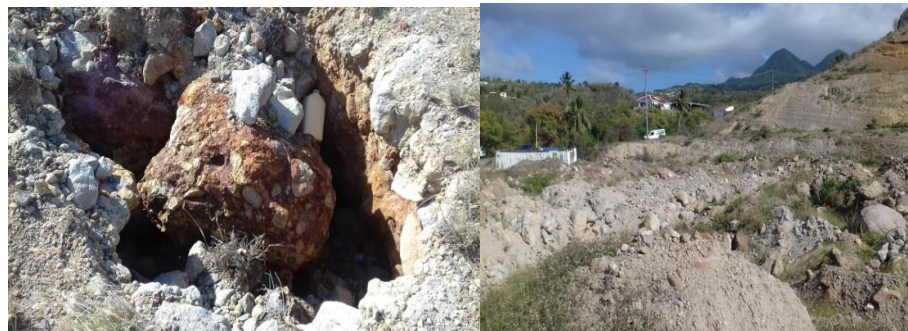
(Photos: Captured by Auditor – May 10th, 2018)

The appearance of sinkholes in and around the site highlighted the danger of using the area for fishing or increased dumping of soil, derelict items and vehicles and boulders. The constant dumping of soil and boulders is adding some protection to the area in the event of high waves according to officials we interviewed; however, loose materials can be easily moved during strong wind and heavy rains, thereby creating potential problems for nearby infrastructure.

- Extraction of a significant portion of Gunn Hill has weakened the superstructure; there is also evidence of landslides to the south of the hill and continuous separation or further break off of the cliff's edge.
- Existing caves on the north western and south sides have eroded further inland and there is the risk that the base will collapse with the various activities occurring on it.

<p>Gunn Hill.</p> <ul style="list-style-type: none"> • MATLHE to ensure the cessation or the minimisation of significant sand mining in the Carr’s Bay area. • MATLHE to ensure the cessation of adhoc dumping of material on the base of Gunn Hill and replace this activity with strong and secured formation of boulders and compacting dumped material to improve the scenic view whilst strengthening the base. • Finally, MATLHE should erect adequate signage in the area and undertake some degree of education and awareness to warn persons of the various dangers to prevent GOM being held liable should an incident occur.
--	--------------------------------------------------------------------------------------------------------------------------------------------------------------------------------------------------------------------------------------------------------------------------------------------------------------------------------------------------------------------------------------------------------------------------------------------------------------------------------------------------------------------------------------------------------------------------------------------------------------------------------------------------------------------------

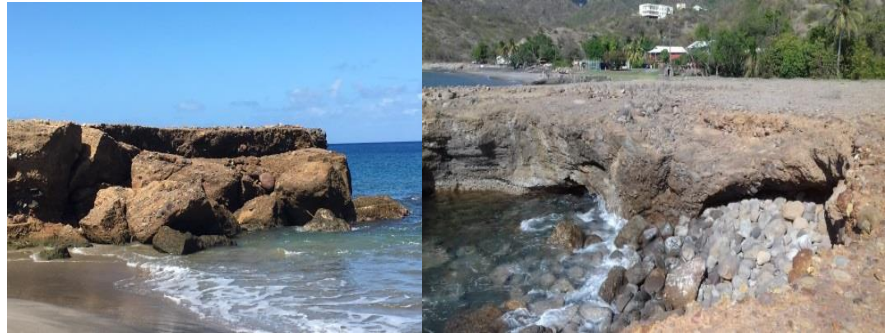
(Photo Credit: Adrian Ryan, N&B Servicentre)

Ongoing mining of significant amount of sand using excavators also threatens the possibility of further erosion to the base and the infrastructure that was previously being protected by the natural landscape before its removal. Many times this activity has occurred without the knowledge of key government officials including the Permanent Secretary, MATLHE. Beach Protection Act Section 3(1) highlighted that it's a criminal offence for anyone to use a motor vehicle to remove sand from any beach without a written permit issued by the Permanent Secretary to the Minister responsible for beach protection matters. Anyone in contravention of this condition is liable to a fine of \$2,000 or 3 months imprisonment.

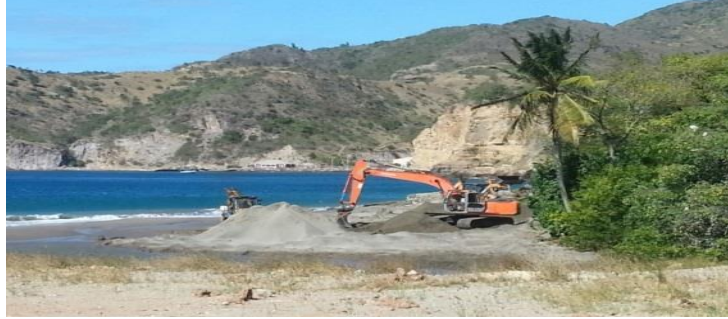
(Photo Credit: Discover Montserrat)

There are a number of watercourses or channels that require dredging throughout the year to ensure water flows easily and prevent excessive blockage which may cause flooding to nearby infrastructure(s). The Physical Planning Act requires written planning permission from the Planning and Development Authority before any watercourse or channel is dredged. However, it was reported that this opportunity is used to also excavate sand throughout the year. There has been considerable public interest in the removal of sand especially from the Carr's Bay area which is considered to be a direct violation to the Laws of Montserrat and damaging of the said beach and other beaches.
